Report of Surface Regularity

Warehouse 1

Calculated and analysed with
Flat 4

Document number: *GP-PRXXXXX_SR001* **Review number:** R01

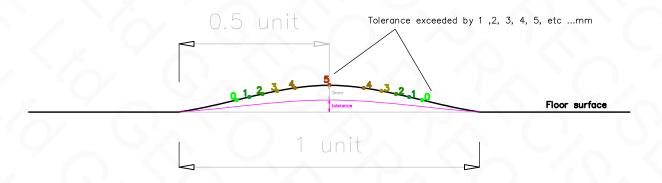
Explanation of error marks:

At projected error calculation (Property B,C) (Unit = as per Property specification)

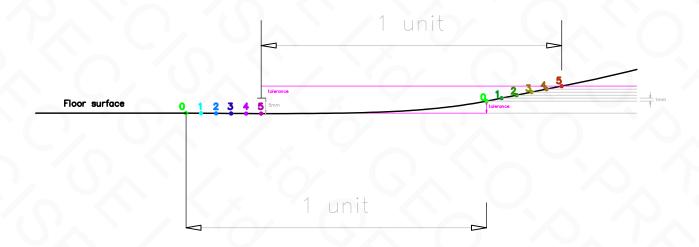
At direct error calculation (Property A)

(Unit = as per Property specification)
